# LKAB KIRUNA SEISMIC EVENT INSPECTIONS

## Emesent Hovermap technology helps LKAB complete fall of ground inspections quickly and safely at Kiruna mine.

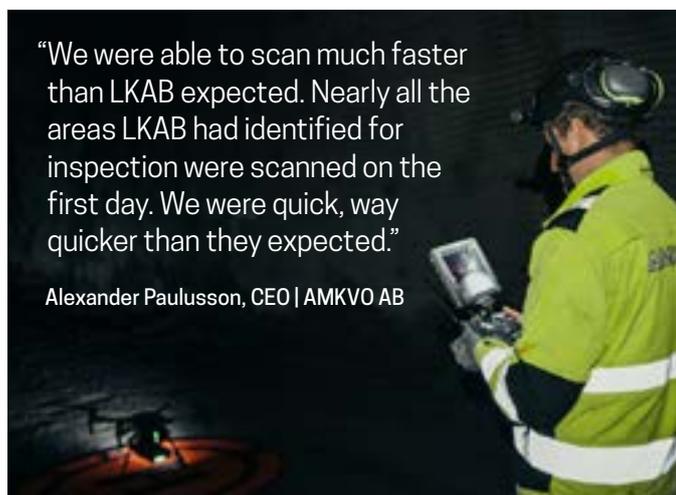
AMKVO conducted over 30 flight and walking scans, at a depth of 1,236 meters below the surface, to map the damage throughout kilometers of drifts in Kiruna.

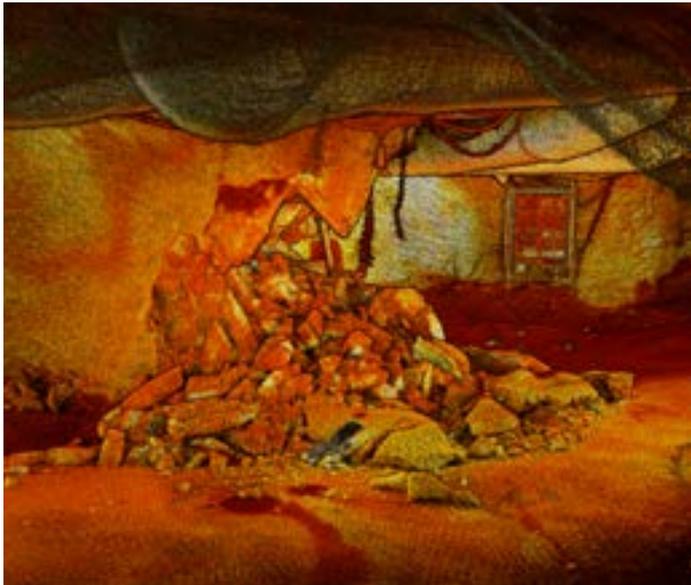
The seismic event triggered rock bursts across kilometers of drifts. Armed with accurate 3D datasets, LKAB engineers were able to start planning remediation work within weeks of the event.

The data was used to inform remediation planning, including the extent of rock reinforcement required and the repairs necessary to damaged plant and equipment within the mine.

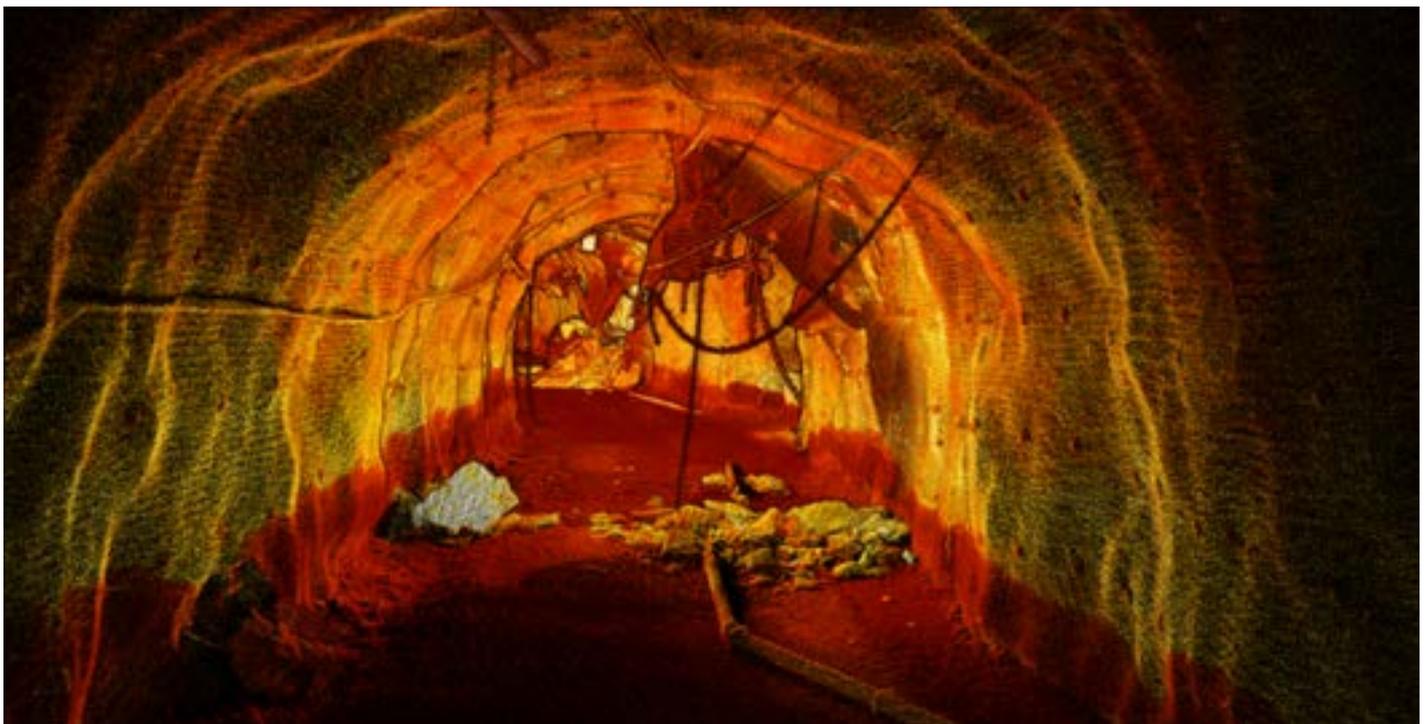
AMKVO delivered georeferenced point cloud data sets, still images and animated point cloud films. LKAB published the films to inform stakeholders, employees and local residents of the extent of the damage.
